JANUARY 1994

Improved Resealing Procedures for the Second Deseal/Reseal Program in RAAF F111 Aircraft Fuel Tanks

MRL Technical Report
MRL-TR-93-64

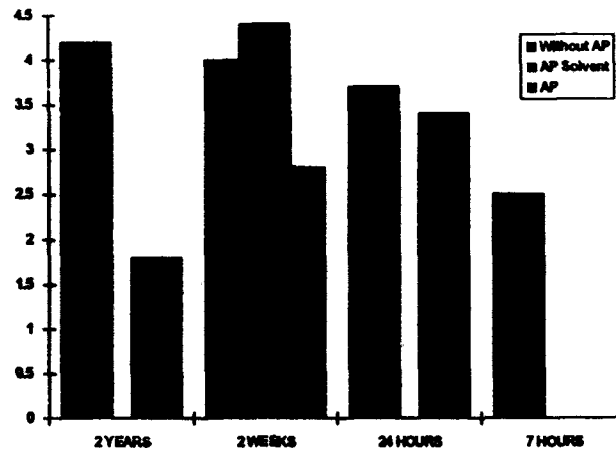
Adhesion of the priming paint/3M barrier coating/sealant system increased with paint cure time up to two weeks and resulted in increasing cohesive failure (and decreasing adhesive failure) within the sealant system. Increased paint cure temperatures similarly improved adhesion as well as reducing the time required to achieve cohesive failure (Tables 3, 4; Figure 2).

Figure 2: Lap shear strength of PR 1750/Barrier coating/Paint system vs Paint Age.

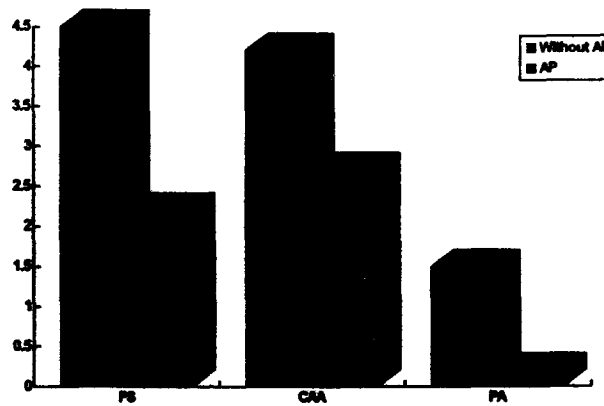
Figure 3: Effect of Adhesion Promoter on Lap Shear Strength of PR 1750/Barrier coating/Paint system.

Examination by both peel and lap shear tests showed that the adhesion of the barrier coating to well cured paints (two years, two weeks, accelerated cure) was greatly reduced when adhesion promoter was applied to the paint. Paints treated with adhesion promoter generally displayed weak adhesive failure between the paint and the barrier coating (Tables 3 & 4; Figure 3).

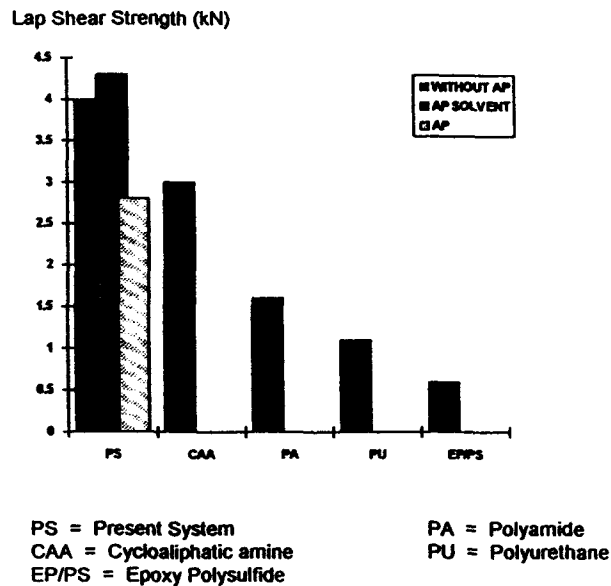
Of the barrier coating compositions examined, the current system was consistently found to have the best adhesion to paint. Where the paint had been fully cured (two years, two weeks, accelerated cure) the cycloaliphatic amine barrier coating was also found to have good adhesion to the paint. Both the polyamide and the polyurethane displayed reasonable adhesion to fully cured paint although, surprisingly, the polyurethane barrier coating failed adhesively between the sealant and itself. This was the only well cured system to fail in this manner. The epoxy/polysulfide had poor adhesion to the paint (Tables 3 & 4; Figure 4).

Figure 4: Lap shear strength vs. Barrier coating composition.

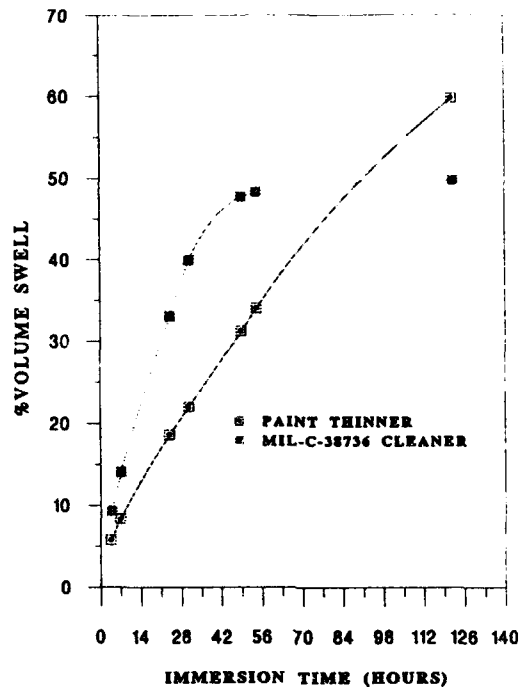
The paints and sealants were not significantly swollen on immersion in Avtur (F35) fuel while the cycloaliphatic amine, polyurethane and polyamide barrier coatings also exhibited minimal swelling. Significant swelling (as determined by weight increase) was observed, however, with the present barrier coating and the epoxy/polysulfide barrier coatings, showing weight increases of 1.4% and 1.1% respectively after three weeks (Table 5). When examined by volume swell in Avtur, the increases in the present barrier coating after two, three and 35.5 weeks were 1.4%, 2.06% and 6.6% respectively. The changes in volume swell in F34 RAAF fuel (avtur containing the antiicing inhibitor diethylene glycol methyl ether (DGME) at 0.15%) were 1.7%, 2.5% and 7.1% respectively (Figure 5).

Figure 5: % Volume swell of Barrier 3580.

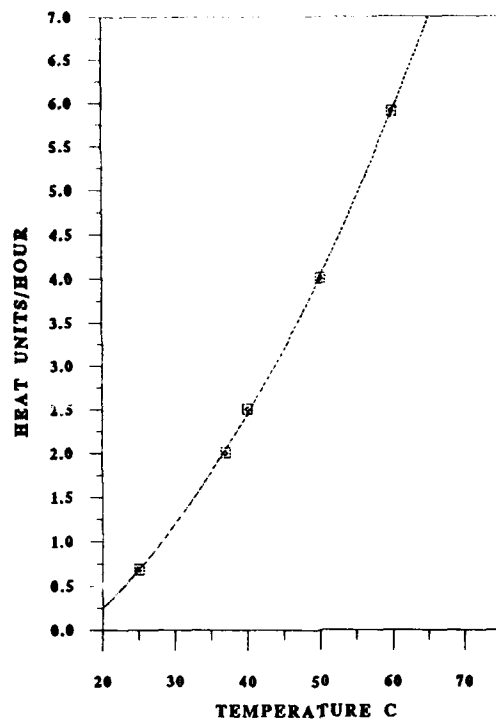
In view of the quick overhaul times achievable using elevated temperatures, RAAF further requested that paint cure schedules up to 60 °C be considered [23]. Following further work, time schedules were compiled at temperatures up to 60°C (Table 6) which met the paint cure requirements [24]. Because of daytime temperature variations, this tabulation was subsequently converted to a graph of so-called 'heat units' (Figure 6) achievable at various temperature-time schedules, a heat unit being defined as the percentage cure gained per hour at a specific temperature, e.g. cure is achievable in 144 hours at 25 °C. Therefore, heat units per hour at 25 °C = $1/144 \times 100 = 0.69\%$ [25]. These units are additive so that if the temperature cycle of an aircraft is known, then the additional time required to achieve acceptable cure can be calculated. Once full cure is achieved (100%), the integral fuel tank paint could be overcoated with barrier coating.

Figure 6: Minimum cure times for integral fuel tank coating (paint).
